**IN SITU DEACIDIFICATION OF VERNACULAR WALLPAPER**

**Submitted in partial fulfillment of the requirement for the degree  
Master of Science in Historic Preservation**

**Graduate School of Architecture, Planning and Preservation  
Columbia University**

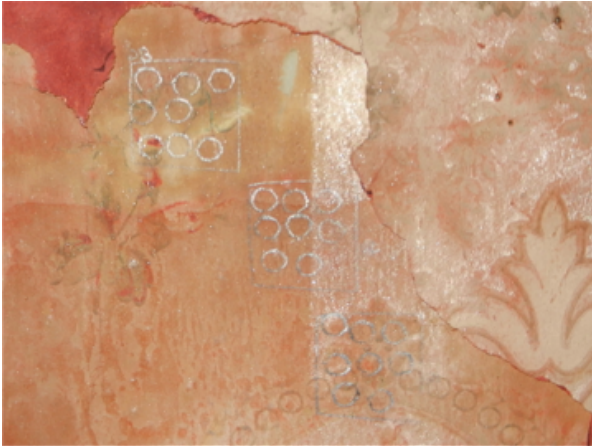
## WALLPAPER 3-a: PAPER SAVER

**After Surface Cleaning**

<b>L*</b>	<b>a*</b>	<b>b*</b>
<b>Sample #1</b>	54.95	+14.69	+23.89
<b>Sample #2</b>	49.83	+15.43	+23.52
<b>Sample #3</b>	53.40	+13.41	+25.39
<b>Avg.</b>	52.73	+14.51	+24.27
<b>Variance</b>	-0.72	-0.74	-1.51
<b><math>\Delta E = 1.83</math></b>

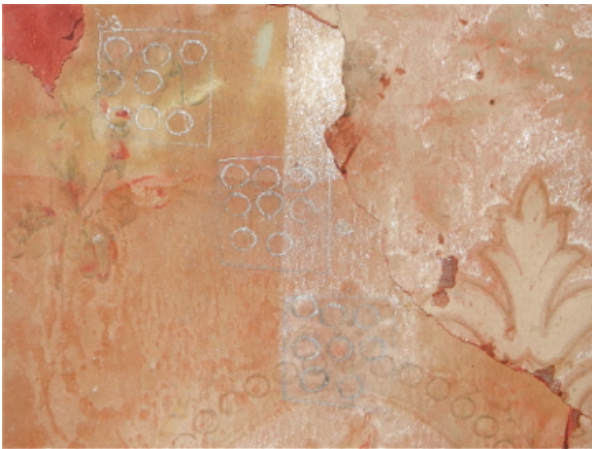
**After Treating**

<b>L*</b>	<b>a*</b>	<b>b*</b>
<b>Sample #1</b>	56.74	+12.87	+19.63
<b>Sample #2</b>	51.09	+14.97	+22.40
<b>Sample #3</b>	53.98	+13.42	+25.66
<b>Avg.</b>	53.94	+13.75	+22.56
<b>Variance</b>	1.21	-0.76	-1.71
<b><math>\Delta E = 2.23</math></b>

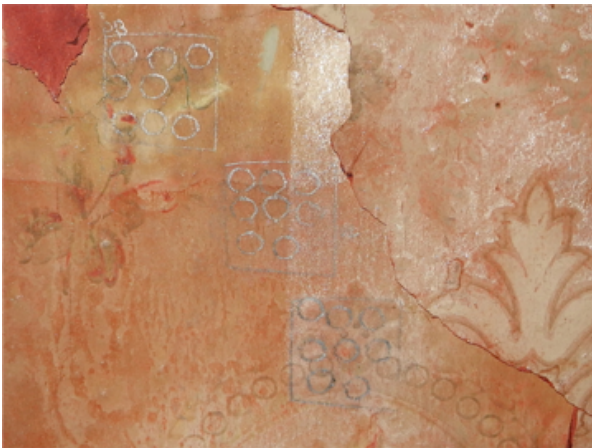
**After Surface Cleaning After Treating**

<b>L*</b>	<b>a*</b>	<b>b*</b>
<b>Sample #1</b>	56.13	+12.90	+19.89
<b>Sample #2</b>	50.97	+14.90	+22.27
<b>Sample #3</b>	52.78	+13.20	+25.01
<b>Avg.</b>	53.29	+13.67	+22.39
<b>Variance</b>	-0.65	-0.08	-0.17
<b><math>\Delta E = 0.68</math></b>

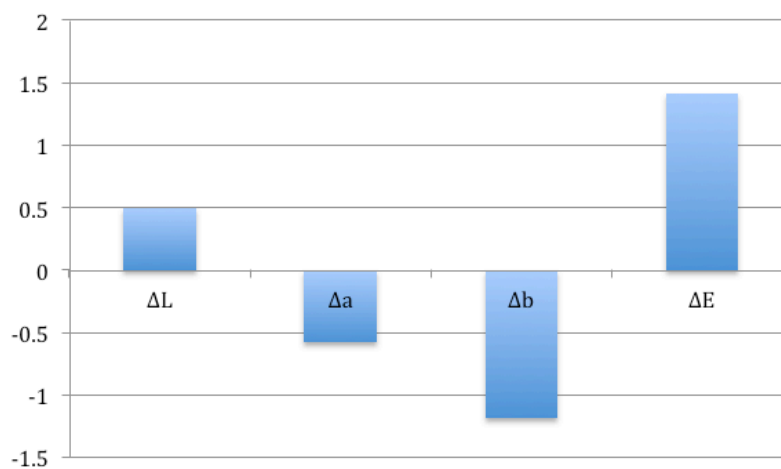
**L\*a\*b\* Delta values between second measurements and final measurements**

Variance between L\*a\*b\* after initial cleaning and after treatment and cleaning:  
 $\Delta L = 0.49$  (lighter),  $\Delta a = -0.58$  (greener),  $\Delta b = -1.19$  (bluer)  
 $\Delta E = 1.41$
